# **FINAL REPORT for the PHASE I TIME-CRITICAL REMOVAL ACTION ACTIVITIES**

## **at the Master Metals, Inc. Site**

### **Cleveland, Ohio**

Prepared by ENTACT, Inc.  
April 24, 1998

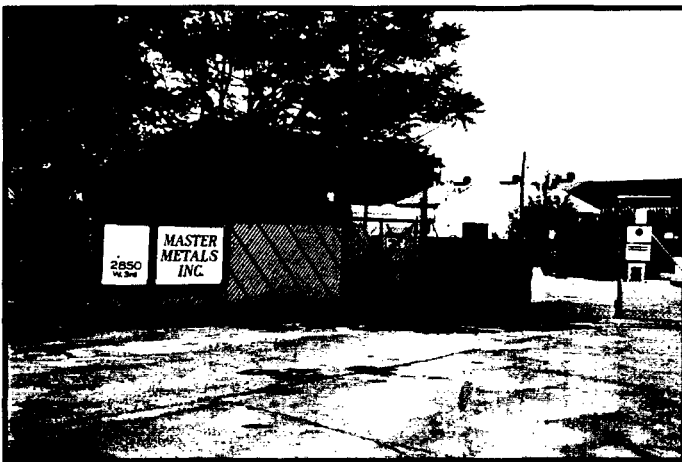
During mobilization, signs were placed on both entrance gates and around the perimeter fence to dissuade trespassers from entering the site and to indicate the hazards present. During the TCRA, site security was maintained 24 hours a day. Perimeter fences were repaired and

Site security and hazard identification

a security guard was stationed at the Site to discourage trespass during periods of inactivity. The preceding activities were effective in preventing the occurrence of any incidents during the removal action.

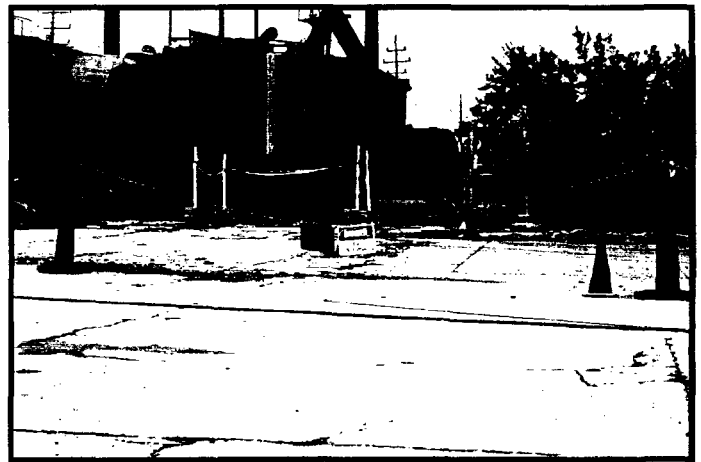
During the TCRA, control measures were implemented to reduce/eliminate the potential for off-site migration of contaminants. Control measures included: the establishment of work zones to contain contamination,

Work zone establishment - Exclusion zone

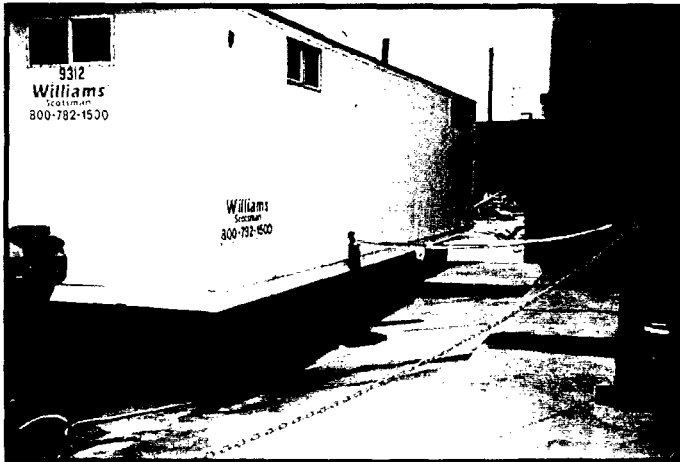
Decontamination Zone consisted of the decontamination trailer on-site which housed the personal protective equipment storage, shower facility, hand wash and eye wash station.

**Personnel decontamination zone**

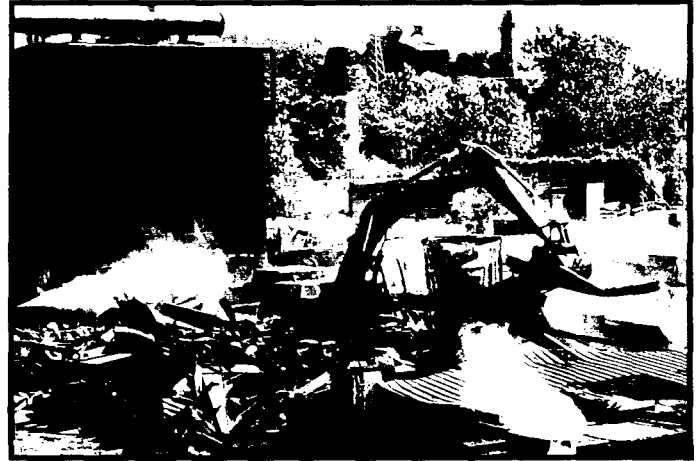
Large exposed waste piles and a layer of lead dust around the site necessitated the use of engineering controls to prevent fugitive emissions. Upon arriving on-site ENTACT crews installed a system of misting units to control airborne dust levels. It was soon determined that this system was insufficient for dust control purposes and a new system was constructed utilizing a combination of fire hoses and sprinklers.

**Dust emission control during the TCRA**

The established sprinkler system was effective in wetting large areas that were heavily traveled by equipment. The fire hoses were also utilized to wet large ground areas as well as wetting the brick and metal structures on-site prior to demolition. This system proved to be more efficient in controlling airborne dust levels.

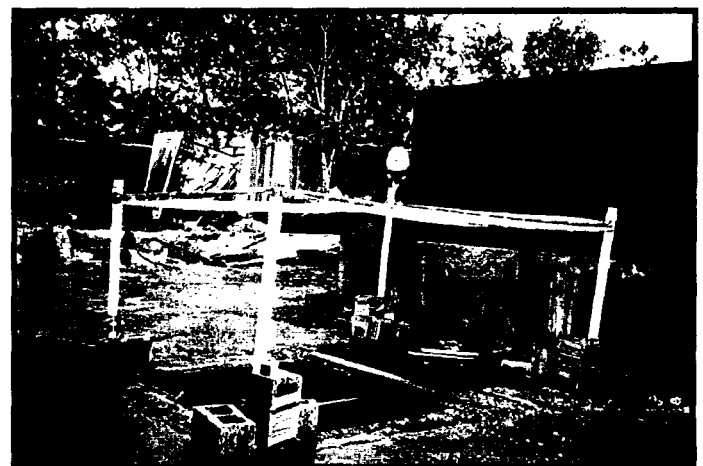
Preparing the site for removal activities consisted initially of removing general site debris and trash from the Support Zone. Debris included trash from the office building on-site which showed evidence of vandalism. Additionally, loose debris was moved out of equipment travel paths throughout the remainder of the site. During this process any open sumps or other dangerous structures were marked to prevent accidental entry.

**Site preparation activities**

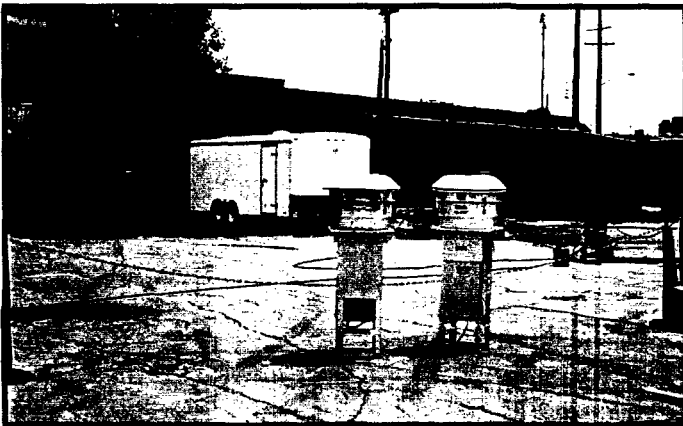
PM10 air sampling stations were constructed around the inside perimeter of the site to monitor ambient air levels of lead particulates. Scaffolding was utilized to establish the PM10 inlets at a height that was in accordance with Clean Air Act (CAA) monitoring methodologies. Figure 2-1 shows the location of the PM-10 air sampling stations. These samplers were positioned in each of the corners of the site so as to provide for upwind and downwind lead particulate concentrations, regardless of overall wind direction.

Perimeter PM10 air samplers

These air samplers were operated continuously over 24-hour periods in accordance with the CAA. National Primary and Secondary Ambient Air Quality Standards for particulate matter of  $150 \mu\text{g}/\text{m}^3$  of air (based on a 24-hour average concentration) and  $1.5 \mu\text{g}/\text{m}^3$  for a 24-hour average for lead (based on a quarterly average) were adhered to throughout the duration of the removal action. These standards and sampling methodologies were also in compliance with the Ohio Environmental Protection Agency rules pertaining to emissions of particulate matter (Chapter 3745-17 of the Ohio Administrative Code).

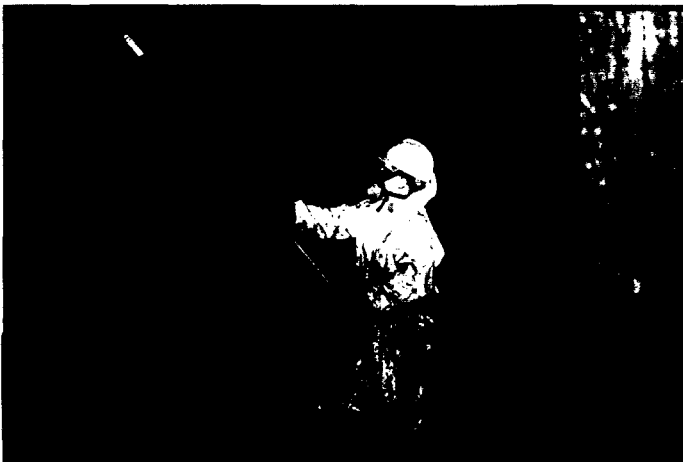
Areas that were heavy in gross contamination were first pre-cleaned. Work crews would first shovel areas with extensive contamination. If areas had considerable amounts of contamination and could be accessed

Decontamination activities

with a machine, a Bobcat would clear away the brunt of debris. Crews would then shovel remaining areas and hydroblast the surface. This method greatly reduced the amount of water necessary for misting. Dust suppression was utilized as necessary during these events.

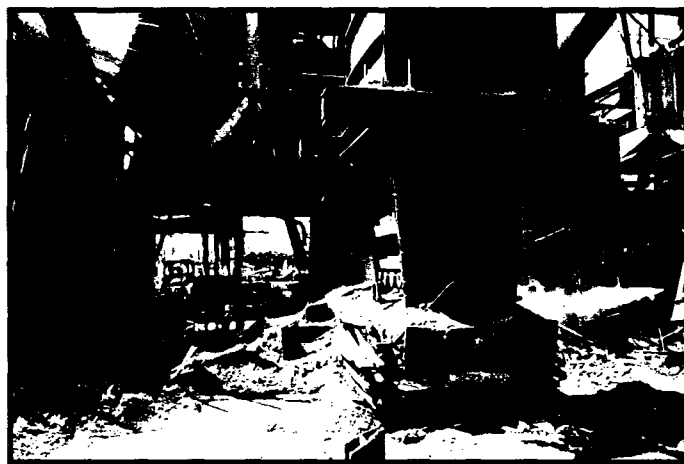
Haphazard salvaging efforts left the furnace unit structurally unstable. Significant overhead piping, steel roof and wall sheeting, and mechanical apparatus were dangling in mid-air by rusted connections. The roof itself had several gaping openings. Extreme caution was exercised to ensure the health and safety of crew members.

Piles of gross contamination were abundant in the interior and exterior of the structure. Decontamination efforts began with these gross piles of contamination. Debris that was removable via a Bobcat machine was completed first. Areas were then cleaned by hand utilizing shovels or vacuum. Following the initial material removal, decontamination of the structure followed. Decontamination of the structure was executed as thoroughly as safety allowed. Decontamination activities utilized high pressure washers, extension wands, and lifting mechanisms to reach upper areas of the building and above ceiling and roof support beams.

Removing gross contamination from the furnace structure

The sequence of decontamination was from the top of the structure down with support crews on the floor containing and evacuating any effluent being generated by crew members working overhead. Resulting scrap metal from this structure was rinsed and visually inspected prior to off-site recycling.

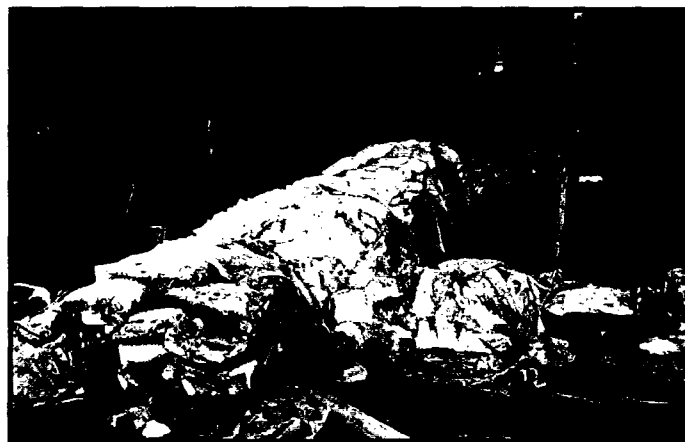
Surplus chemicals stockpiled in furnace structure

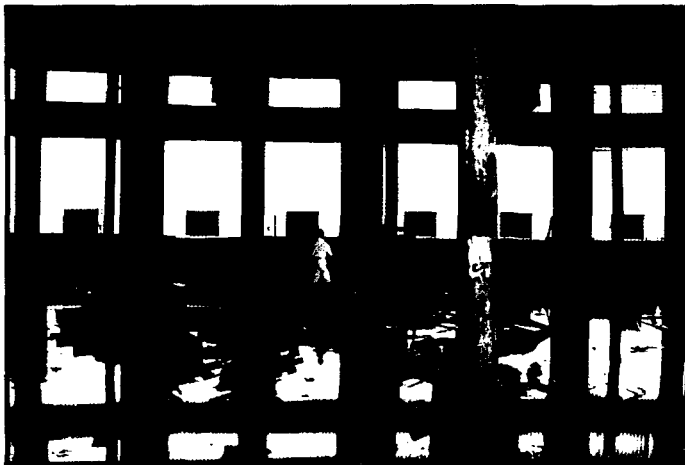
Decontamination efforts began with the removal of the wood and steel debris. This material was decontaminated utilizing hydro-blasters and sampled. A Bobcat

Removing general debris from roundhouse building

machine was used to move and stage this material for sampling followed by off-site disposal or recycling.

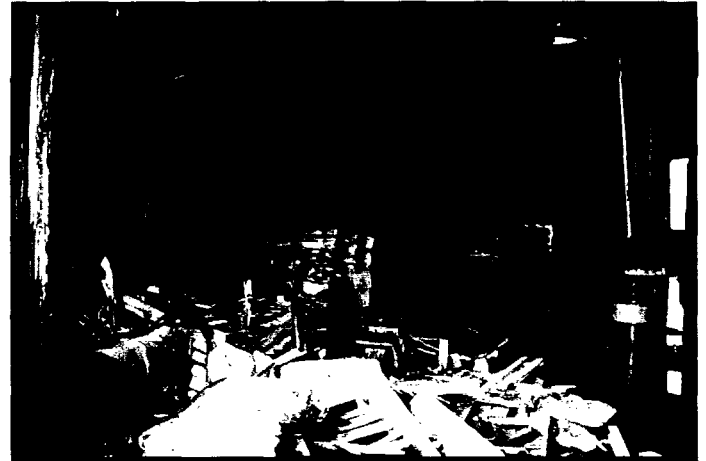
Upon removal of the wood and steel debris, vast amounts of oily sludge and trash still remained in piles on the floor located throughout the building. This material was condensed into a large stockpile and sampled. Due to the nature of this material, it was deemed unsuitable for treatment and was sent off site for disposal at a hazardous waste landfill.

Chemicals and drums in roundhouse building

Once the building was emptied of its contents, it was ready for final decontamination. However, because the roof of the structure was badly deteriorated in many areas, it first required repairs to help eliminate additional water from entering the structure. A roofing contractor was procured to patch areas where roofing material was absent. Once complete, the entire structure was decontaminated utilizing high pressure hydro-blasters, extension wands, and lifting mechanisms. Floor sumps located in the structure were used to collect and contain wash water.

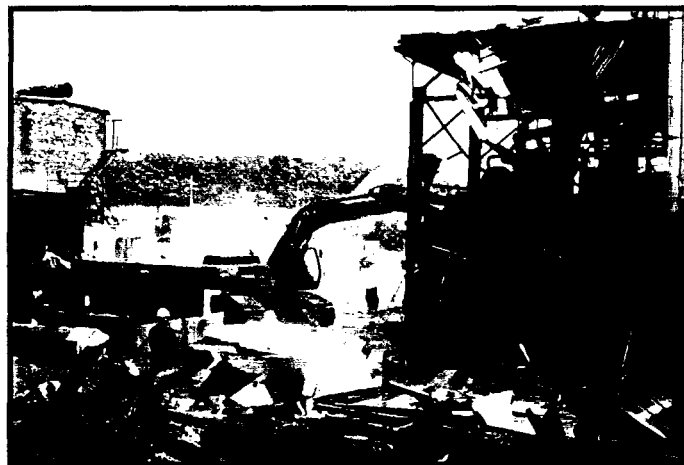
hibited close proximity, and that only two-thirds of the structure would first be demolished. The furnace structure required special attention because of its severely deteriorated condition and inconvenient location of two massive ball mill furnaces.

Dust control and demolition of furnace structure

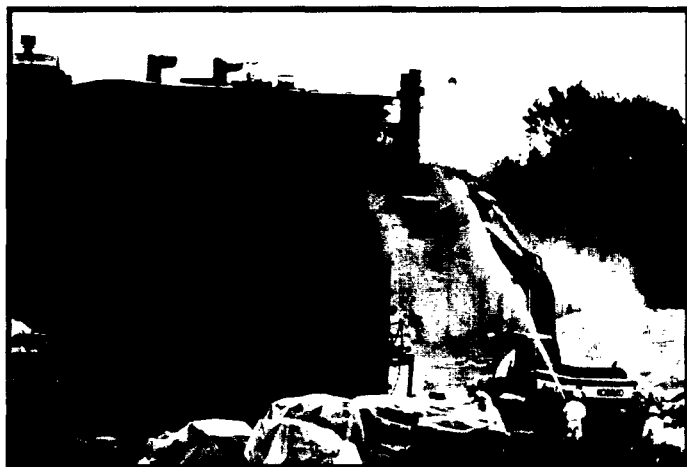
The baghouse facility was constructed of a brick exterior and cinder block interior. It had been resurfaced at least one time in the past. Some of its mortar had deteriorated and a very large crack was evident on its south face. Particular interest was placed on this building because it contained substantial amounts of K069 waste.

Demolition of baghouse building

Demolition began on the western portion of the building under misting. Great care was taken to demolish only the top sections of the structure that had been previ-

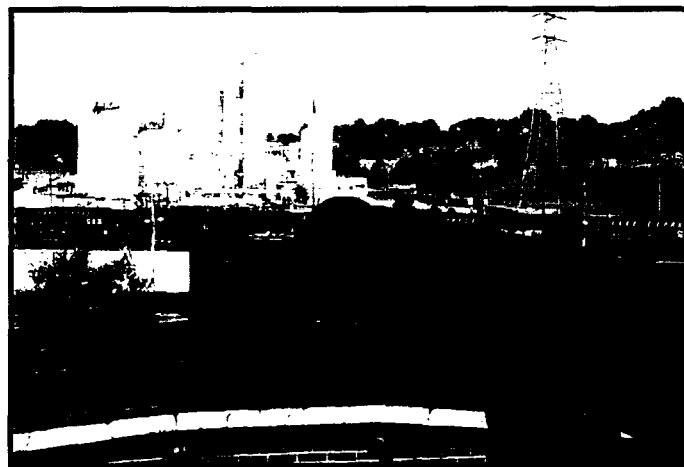
Contaminant removal prior to demolition

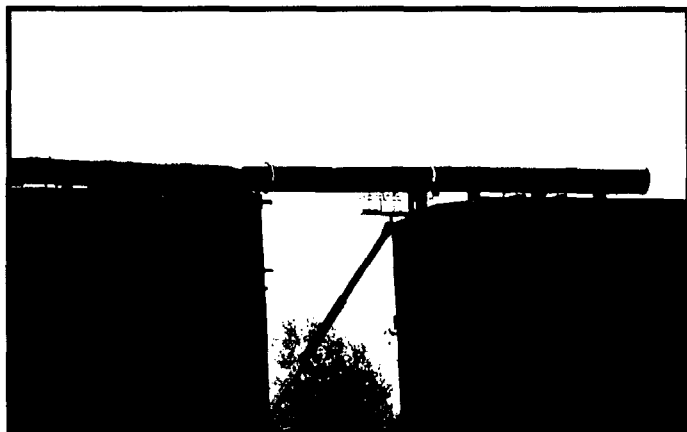
access door was removed from the stack to inspect its inside. The stack was made only of steel, was clean, and was unlined. All steel support connections from the stack to the buildings and cat walks were cut utilizing an oxygen/acetylene torch. This left the stack free and clear from all buildings. A high pressure water spinner was then run through the top of the stack downward to moisten any potential dust in order to minimize emissions. Remaining steel support cables attached to the stack were removed; a cut was made to the base of the stack, and the stack was dropped to the ground. The stack was cut to size and disposed of off-site.

**Stack removal in preparation for demolition**

The area immediately surrounding the base of the brick baghouse structures were pressure washed and polyethylene sheeting was placed on the concrete slab to prevent cross contamination during demolition. The exterior and interior of each structure was wet down to help minimize dust emissions.

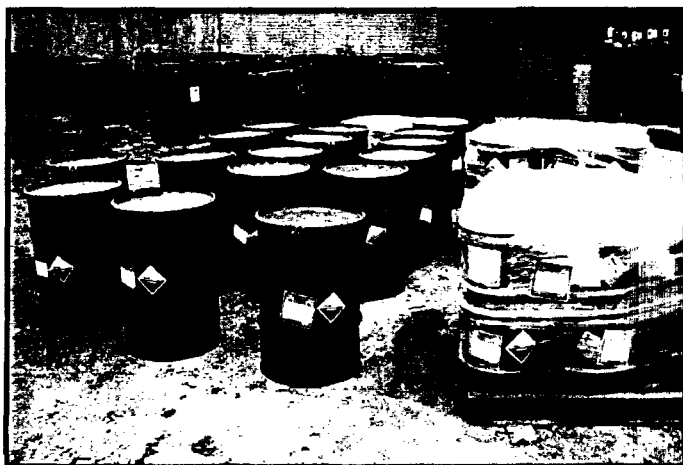
The southwestern portion of the site contained large quantities of drummed solid media. After the treatability study determined which solid material in this area could be treated, the containerized materials were segregated based upon analytical characteristics. Material amenable to treatment was staged for processing, while materials that were characteristically hazardous and could not be treated were handled as hazardous waste and disposed of accordingly.

Removal of drummed chemicals

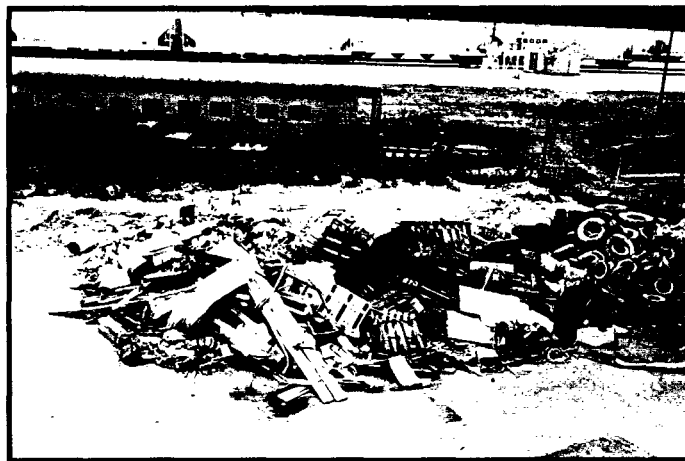
The majority of the remainder of solid hazardous media on site was present in various sizes of exposed piles. Each of the twelve identified waste piles were characterized by laboratory analysis and were included in the

Wood debris pile prior to sampling

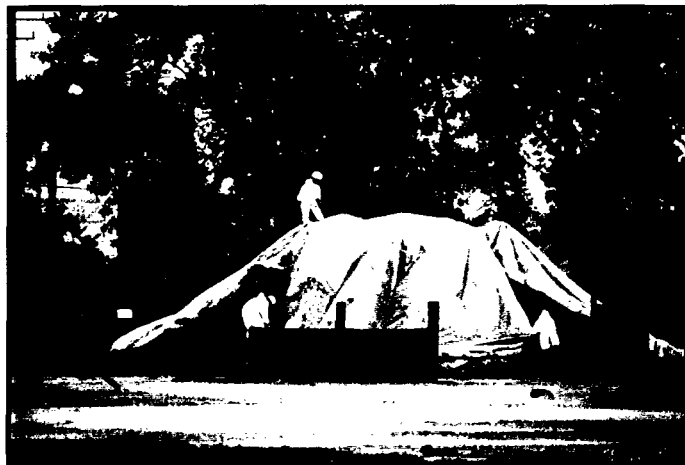
Waste pile preparation for treatment activities

treatability study. Waste piles determined to be similar in chemical characteristics based upon laboratory analysis were combined prior to treatability analysis. Waste piles amenable to ENTACT's treatment process were staged for subsequent treatment.

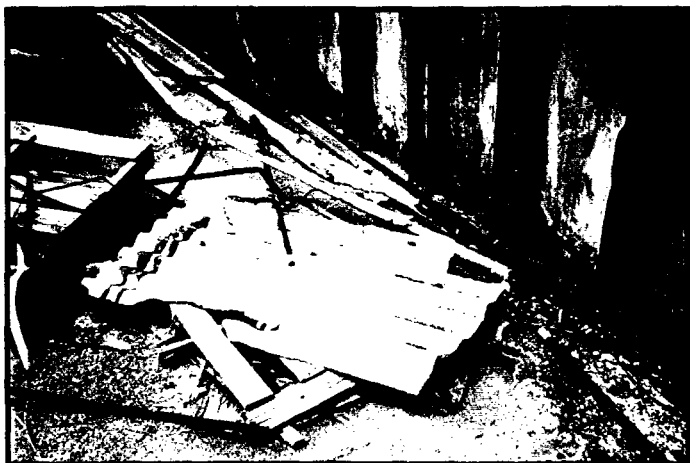
There were several areas on-site where ACM was present. Figure 6-1 depicts the sampling locations utilized for the ACM removal on site. Through laboratory analysis ACM was identified in the roof tile material of the baghouse structure, roof debris piles from the white metals building, and loose roof material located east of the roundhouse near Third Street. ACM scattered throughout

Asbestos containing materials on site

the gravel area east of the roundhouse and the ACM debris piles from the white metals building were wetted, double bagged, and loaded into roll-off boxes for disposal. Non-friable roof material from the baghouse structure was wetted and loaded into a lined roll-off box during the demolition of the structure.

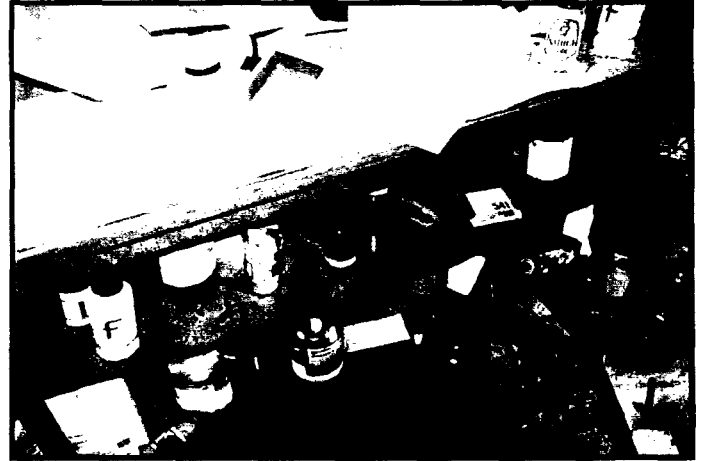
An additional laboratory was discovered in the office building which also contained an abundance of

**Laboratory chemicals upon mobilization**

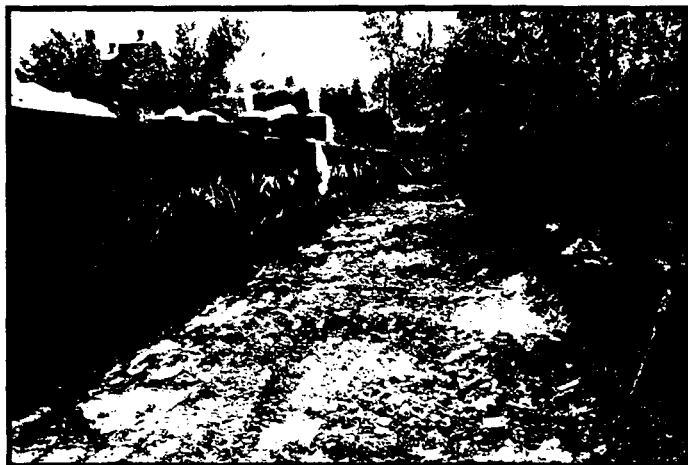
Excavation of areas not covered by permanent structures began along the western border of the site. Pre-screening was conducted utilizing the XRF analyzer and the established XRF vs. TCLP correlation discussed in Section 7.4. This was the location of the railroad spur

Excavated area - Western border of site

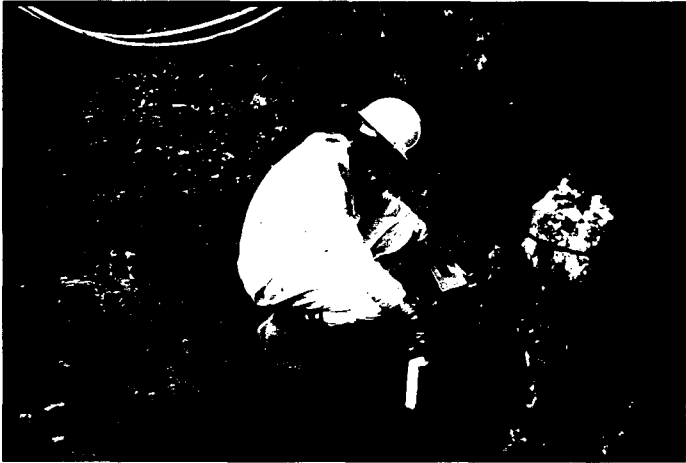
After the initial calibration and standardization, the XRF unit was utilized to screen the excavated areas in the following manner. The location and sample ID were identified through the establishment of the coordinate grid system. XRF readings were collected directly from the ground surface where material moisture content allowed direct screening in place. For sample locations underwater or where moisture was visible in the material, a sample was collected in the field and dried in a controlled environment prior to screening.

**XRF Extent of Contamination (EOC) survey**

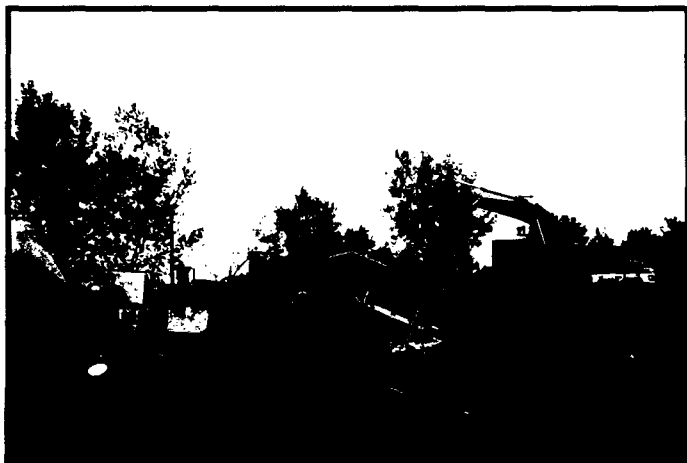
Particle size reduction was achieved by utilizing a concrete processor for on-site materials larger than six (6) inches in diameter. Stockpiled material amenable to treatment was loaded directly into the hopper located on the rear of the crushing unit. This hopper and belt feeder also served as a segregation process in that metal debris and solid lead material could be removed at this stage and containerized for recycling.

**Crushing unit for treatment**

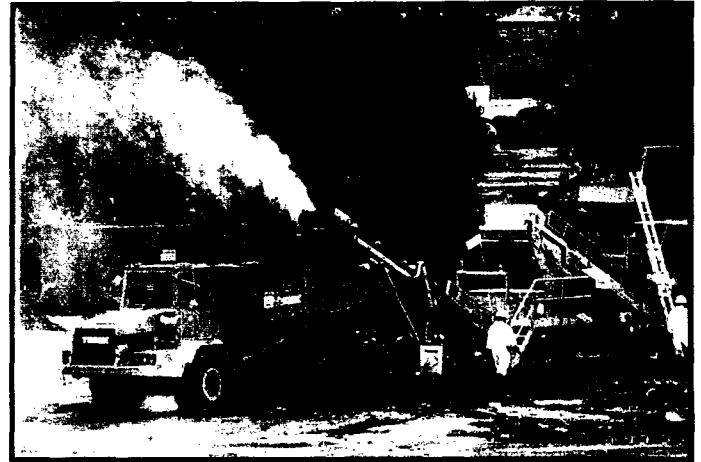
Transportation of treated material
